CONNECTICUT RIVER BASIN
WEST HARTFORD, CONNECTICUT

**HARTFORD RESERVOIR NO.2 DAM
CT 00003**

**PHASE I INSPECTION REPORT
NATIONAL DAM INSPECTION PROGRAM**

DECEMBER 1980

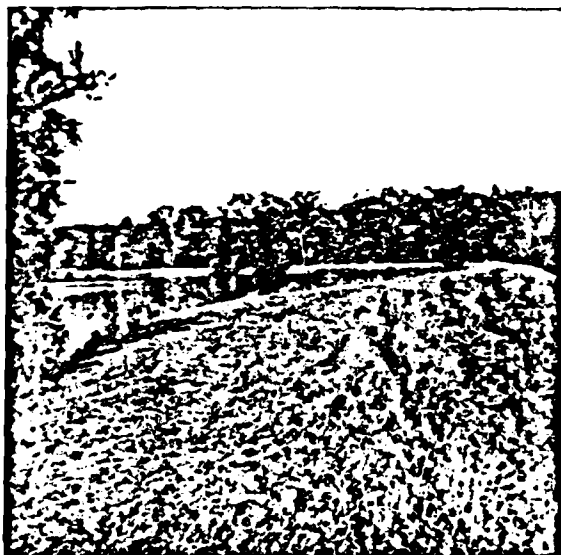
#2. Grass crest in generally good condition. Downstream face overgrown.

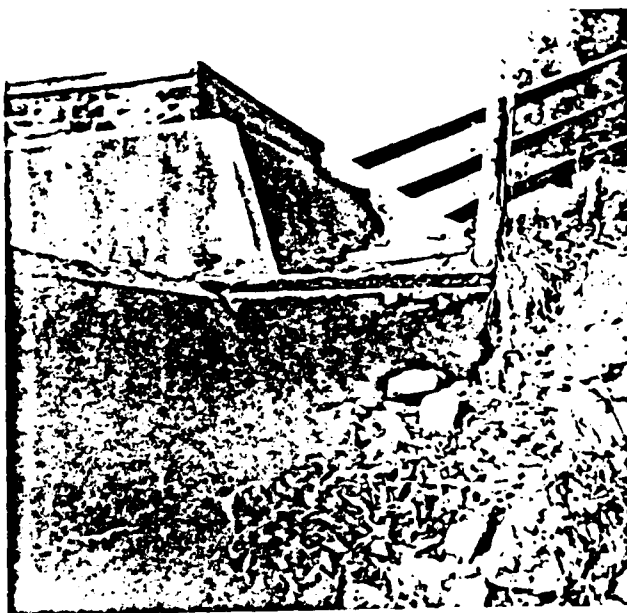
#3 Walkway slab at spillway is undermined

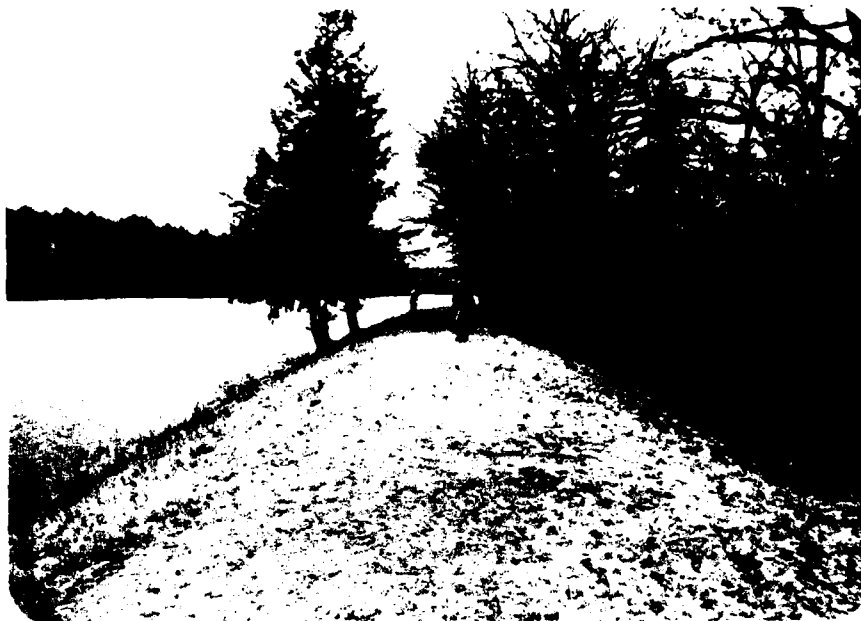
PHOTO NO. 1

The crest of the dam is grass-covered, Photos 1 and 2, and appears to be fairly level and in good condition with several bare spots noted. The upstream slope is protected by a layer of riprap, Photo 3, which in most areas extends approximately 2 feet above the normal waterline and is overgrown with vegetation. The majority of the upstream slope above the riprap is grass-covered, although erosion of one area was noted where grass is missing and riprap did not extend above the waterline, Photo 4. Several large trees, up to 18-inches in diameter, were present at the waterline, Photos 1, 2 and 4.

DAM CREST

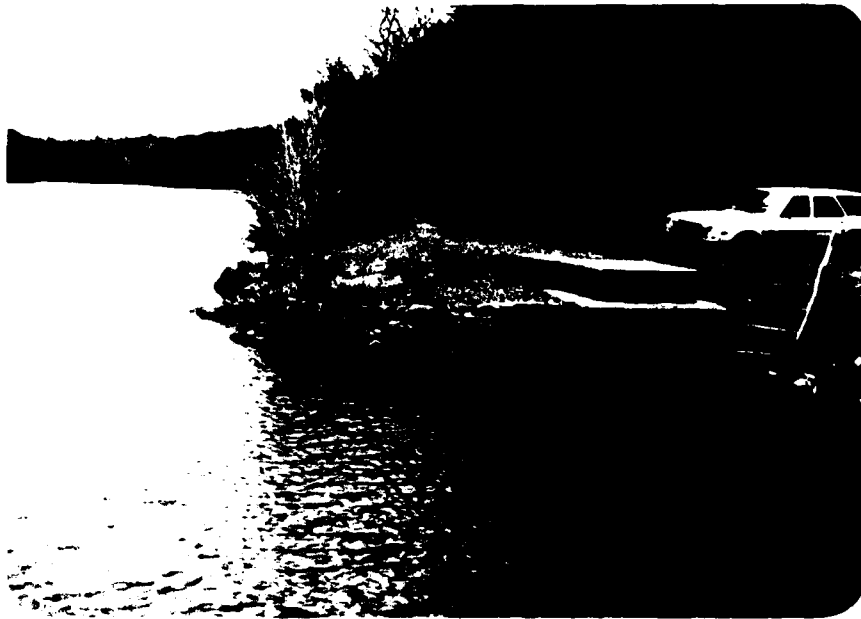
PHOTO NO. 12

The overflow spillway consists of a concrete weir founded on rock with concrete and stone masonry training walls, Photos 10, 11 and 12. The concrete weir and training walls appear to be in good condition with the exception of a hairline crack noted in the right training wall at the downstream face of the weir. The right upstream stone masonry training wall appears to be bulging out approximately

LEFT TRAINING WALL
